TECHNICAL REPORT ARCCB-TR-99010

**ANALYSIS OF A PISTON EXPERIENCING
ENVIRONMENTALLY-ASSISTED CRACKING
AS A RESULT OF COMPRESSIVE OVERLOADING**

**E. TROIANO
G. N. VIGILANTE
J. H. UNDERWOOD
C. MOSSEY**

JUNE 1999

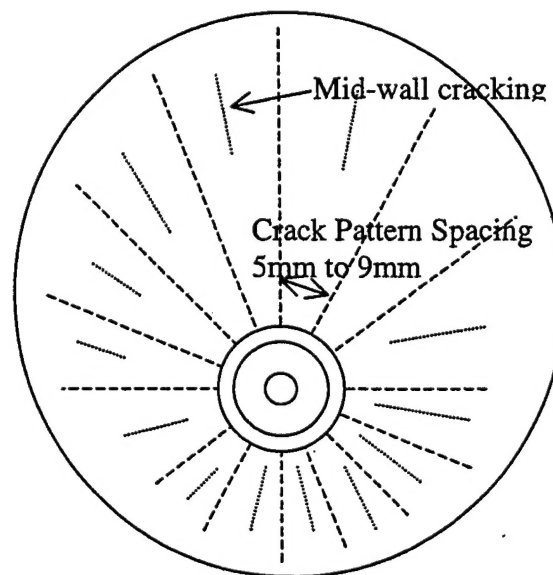
In August 1997, testing was conducted of a piston utilized in the seal of a closed-ended pressure vessel. Testing included 100 loading cycles, at pressures ranging from 69 MPa to 414 MPa. Upon completion of the test, the component was disassembled, cleaned, and inspected. Although no pressure losses were observed during the test, it was noticed that cracking of the Maraging 200 steel piston had occurred (Figure 1). Cracking was not observed during testing because cleaning of the system was strictly forbidden. The cracking pattern emanated in a radial fashion around the piston, yet none of the cracks broke through the thickness of the piston. Cracks ranged in length from barely noticeable, to approximately 20-mm in length. Cracking was also observed at many locations approximately half the distance between the center of the piston and the outside diameter. In some cases, cracks that started in the center of the piston appeared to "link up" with the cracks that started at the midpoint between the center and the outside diameter. There was also a characteristic ripple where the cracked surfaces protruded upward, producing an uneven texture on the top surface of the piston. The crack pattern appeared relatively evenly spaced, with a crack spacing of approximately 5-mm to 9-mm.

Figure 1. Radial cracking pattern on piston face.

Later in August 1997, testing resumed with the same piston. However, this time cleaning of the surface was allowed for inspection purposes. The sequence of testing consisted of 112 loading cycles ranging from 69 MPa to 414 MPa. Three cracks were chosen and monitored for overall crack length. One of the cracks did not grow in length during the entire 112-round sequence, the second crack extended in length by slightly over 1-mm, and the third crack extended over 3-mm in length. The crack extension observed at the surface did not show a constant crack growth rate, and the cracks grew essentially their entire length increment in only a few loading cycles.

A closer look at the finite element model indicated that the piston did deform into a "dish-like" shape during the loading process. The resultant stresses were compressive on the top surface, exceeding the compressive yield strength of the material, and were predicted to be approximately 1600 MPa.

Ultrasonic inspection of the piston indicated that most of the cracks ranged in depth from approximately 1.0-mm to 1.5-mm, with the maximum depth of each crack occurring at the center of the piston. Magnetic particle inspection of the piston revealed that none of the cracks extended to the outside diameter of the piston. Inspection of the top surface revealed a "dishing" effect. The top surface of the piston was 0.05-mm higher on the outside diameter than in the center. The backside of the piston was also plastically deformed and dished. The center of the piston was 0.025-mm higher than the outside edge of the back of the piston.

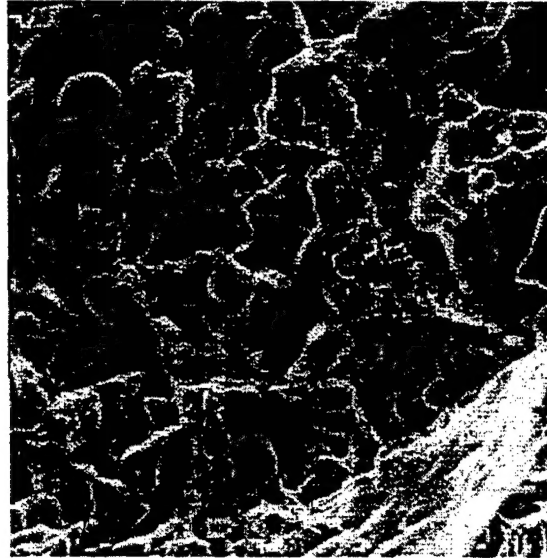
After a thorough cleaning of the surfaces (with plastic replicas), some portions were exposed near the tip of the cracks. Figure 2 is at the tip of the first crack and clearly shows intergranular cracking and the post-fracture ductile tearing that occurred when the crack was sectioned. The second crack seemed similar to the first in fracture appearance, and again intergranular cracking was the predominate fracture morphology. The logical conclusion is that the cracks were not driven by mechanical fatigue loading, but rather the result of hydrogen-induced cracking.

Figure 2. Crack tip morphology showing intergranular cracking.

In this case, the hydrogen is contained in the pressure vessel contents and cannot be avoided. The sustained tensile stress is a result of compressive yielding, and is inherent in the design, which at this point could not be changed. The Maraging 200 material is a highly susceptible material that is prone to hydrogen embrittlement. All of these conclusions are self-consistent, and suggest the most likely mechanism of failure is hydrogen-induced cracking.

These conclusions also suggest that a suitable method to prevent hydrogen cracking was to create a barrier to prevent the hydrogen from contacting the highly susceptible, highly stressed base material.

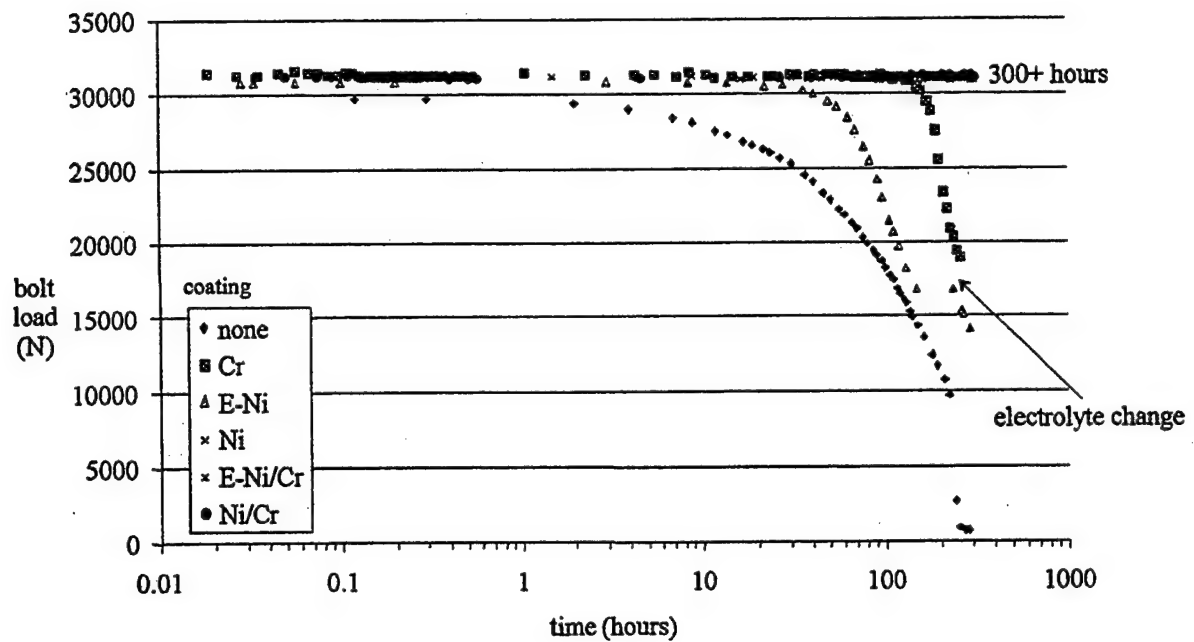
Figure 4 clearly highlights the resistance that each of the coatings provides to the Maraging 200 base material. We can see that the Maraging 200 material with no coating provided approximately one hour incubation time, followed by a decreasing load as monitored by the instrumented bolt. After approximately 250 hours of exposure, the cracking had reached an apparent threshold value, and no further decrease in load was observed. The specimen with the electroless nickel (E-Ni) protective coating provided approximately 30 hours of protection, and rapid cracking of the underlying base material resulted. In this test, after approximately 150 hours of exposure, the cracking appeared to arrest. Cracking immediately resumed after the electrolyte was changed. We believe that the electrolyte had become depleted, or because the electrolyte is hygroscopic, it may have absorbed enough moisture to severely compromise the pH of the acid. The specimen that was protected with the chromium coating (Cr) provided approximately 150 hours of protection, and was followed by rapid cracking of the base material. The specimens protected with the electroplated nickel (Ni), electroplated nickel and chromium (Ni/Cr), and electroless nickel and chromium (E-Ni/Cr) all withstood the 300 hours of exposure with no degradation of the base material.

Figure 4. Environmental cracking resistance of Maraging 200.

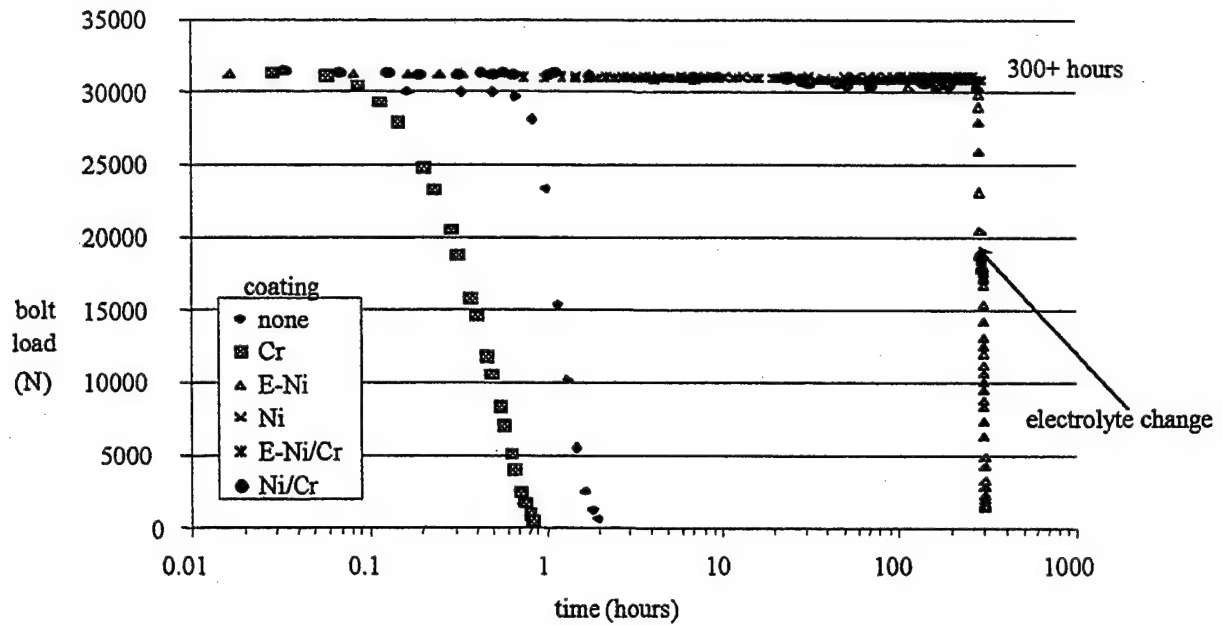
Figure 5 shows results of the tests on the 1300 MPa A723 steel. The first thing to note is that the A723 steel with no protective coating provided less than one hour of incubation time, and cracking had proceeded to the threshold in less than two hours. The chromium coated specimen provided approximately 0.1 hour of incubation time and had proceeded to the threshold in less than one hour. We believe this is a direct result of microcracking, which is often observed in chromium plating. This microcracking acts as crack initiation sites and rapidly accelerates the incubation time. The specimen coated with electroless nickel provided approximately 280 hours of incubation time, at which time the specimen began shedding load. At approximately 290 hours of exposure, the cracking arrested and an electrolyte change was performed. Cracking immediately resumed and at 300 hours, the specimen had attained the threshold. The specimens with electroplated nickel, electroplated nickel and chromium, and electroless nickel and chromium attained the 300 hours of exposure with no cracking and no shedding of load.

Figure 5. Environmental cracking resistance of A723 steel.
